Report

Serious incident on **7 September 2010**
at **Lyon (69 France)**
to the **Boeing 737-400**
registered **TC-TLE**
operated by **Tailwind Airlines**

Bureau d'Enquêtes et d'Analyses
pour la sécurité de l'aviation civile

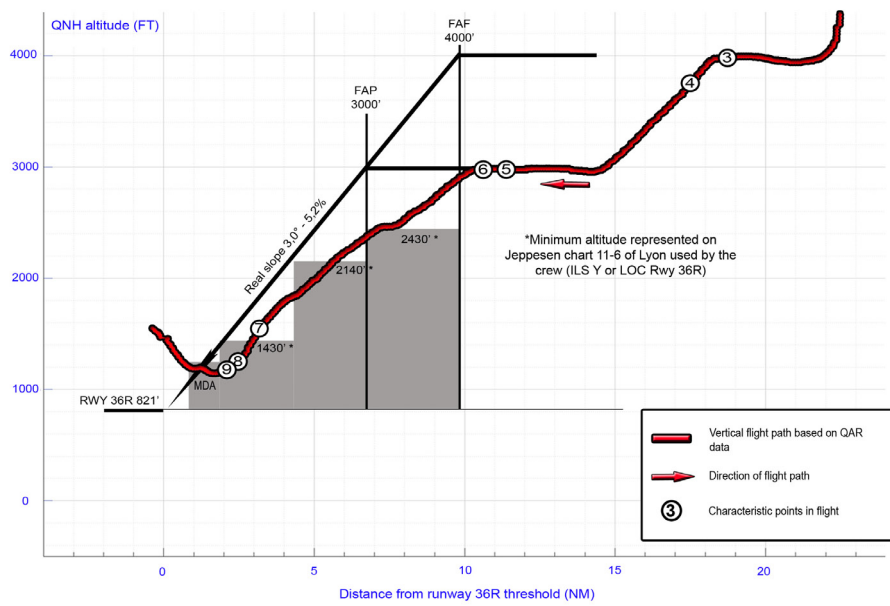
Figure 1a: Vertical flight path

At 17 h 09 min 52^⑧, the controller had received no answer. While he was repeating his message, the MSAW warning was activated. He ordered a go-around three times.

The whole of the final descent was made under the published approach profile.

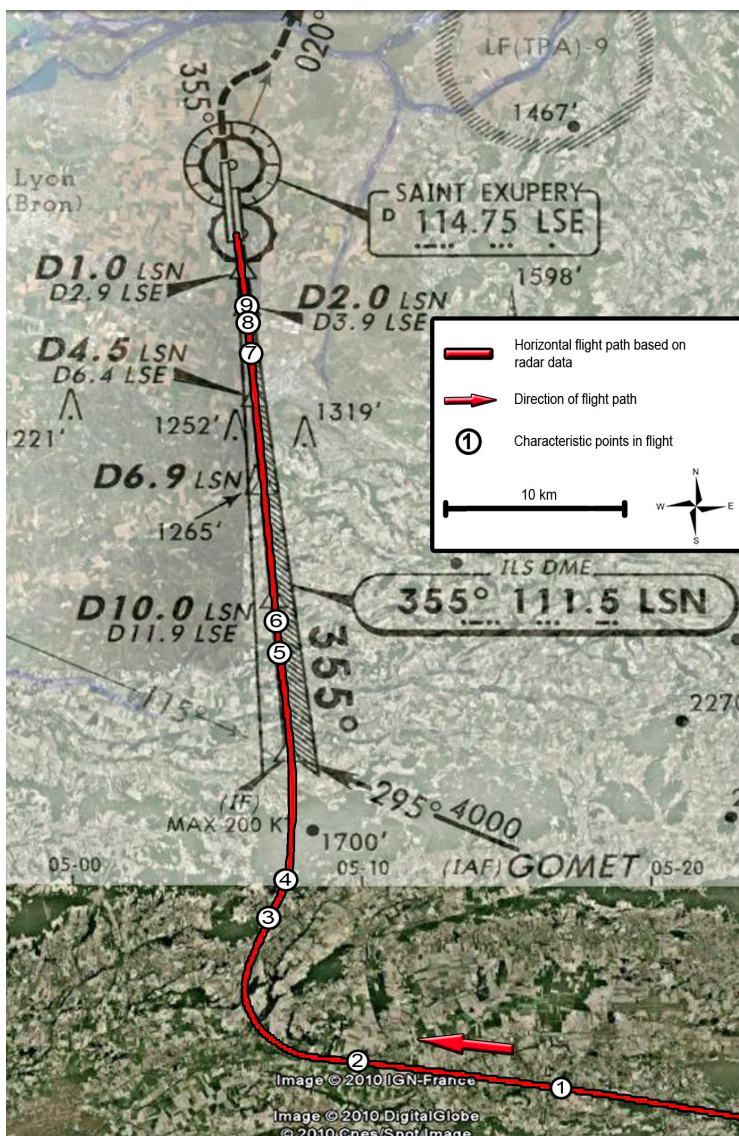
Figure 1b: Horizontal flight path

At 17 h 03 min 22^②, the crew signalled that they were approaching the localizer. Their heading was 270°. The controller asked them to turn to heading 020° and to intercept the localizer. The aircraft started to turn when it crossed the localizer, and then established on the requested heading.

At 17 h 07 min 12^⑥, the aircraft was aligned with the localizer and stable at 3,000 ft. It started its final descent 10 NM from the threshold.

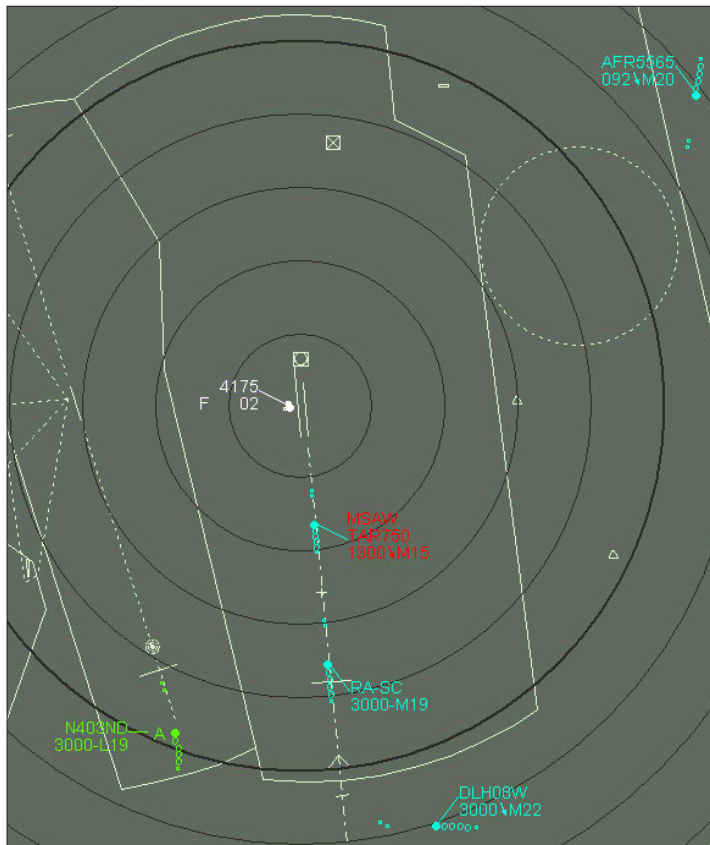
Figure 2: Extract from the radar playback for the event

The principle of this system is to calculate an extrapolated position approximately 35 seconds from the radar track. This position is then compared with a digital model of the terrain and a database of obstacles. If the extrapolated position is located at a height below a certain threshold in relation to the ground or to obstacles, respectively 300 ft or 600 ft for one and the other of the two extrapolation hypotheses, a warning is generated. It is then displayed on all the radar screens in the IFR room and in the control tower cab, except if it is located in the exclusion zones that are intended to avoid false warnings. All the labels of the track flash red and white alternately. An aural "Low altitude alert" warning is also issued.

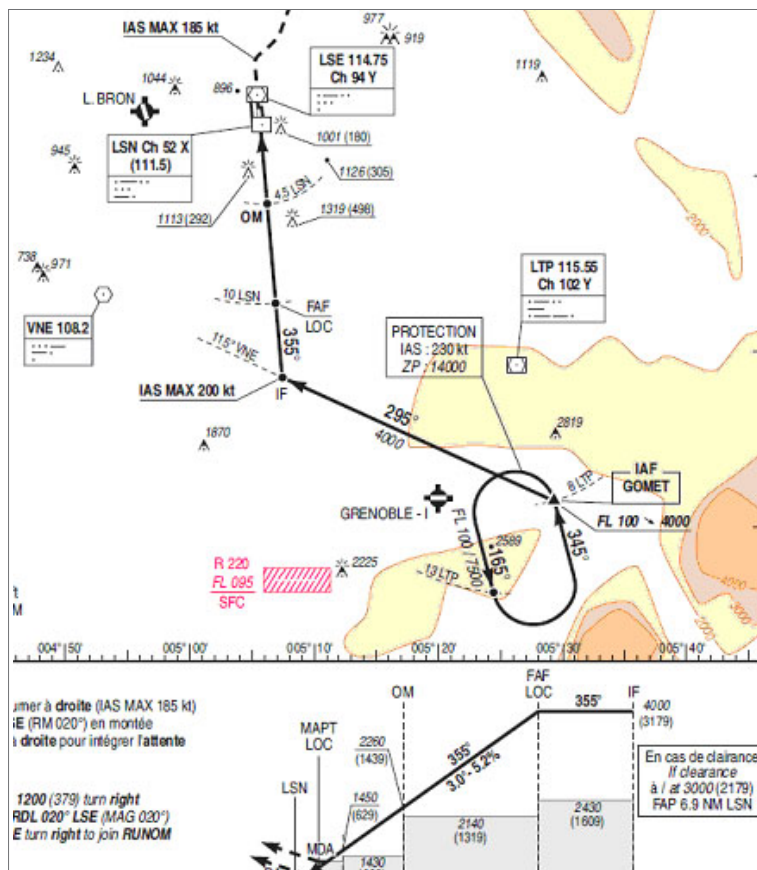
Figure 4: Extract from file AD2 LFLL IAC10 showing the “ILS y [...] or LOC 36R procedure”

- The approach from the initial approach fix GOMET, “ILS y [...] or LOC 36R”, provides for a descent to 4,000 ft minimum, the level-off altitude of the intermediate approach. The final approach fix is located at 10 NM from the LSN DME. A box stipulates “In the case of clearance at 3000 ft, FAP at 6.9 NM LSN”, as illustrated by the following extract (see the complete file AD2 LFLL IAC 10 in appendix 2):

The MDA published for the LOC 36R approach is 1,250 ft. The threshold elevation is 821 ft.

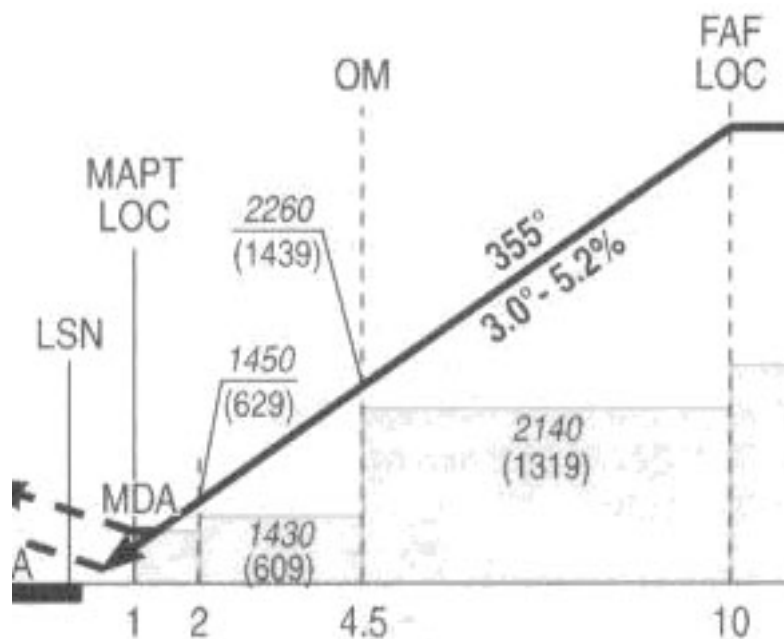
Figure 6: Final approach segment

The FAF - OM segment has an MOC of 90 m leading to the minimum altitude of 2,140 ft. The penalizing obstacle is located between the FAF and the upstream FAF⁽⁶⁾, i.e. at a distance slightly greater than 10 NM from the threshold.

The OM - 2 NM segment has an MOC of 75 m leading to the minimum altitude of 1,430 ft. The penalizing obstacle is located between the OM and the upstream OM, i.e. at just over 4.5 NM from threshold.

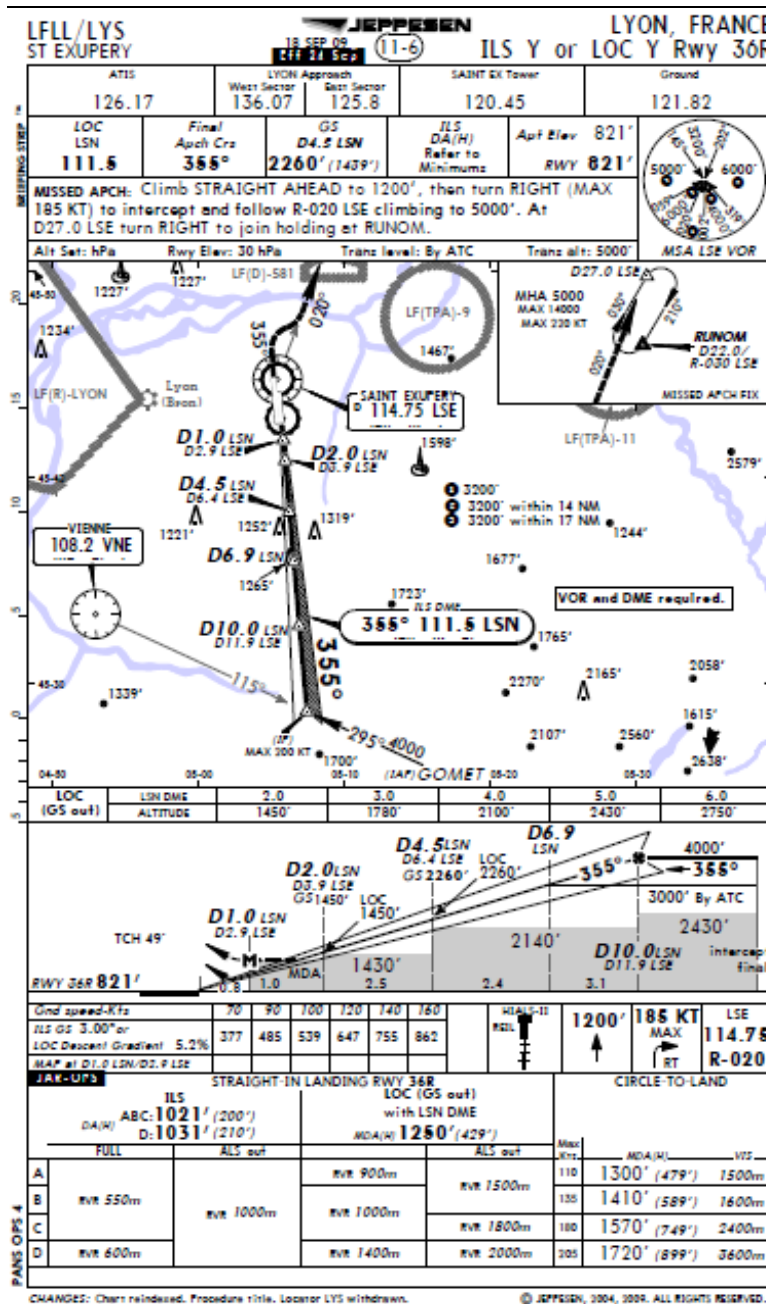
Figure 7: Approach chart used by the crew. The Jeppesen glossary indicates that the symbol (cross), used here at the intersection of the step-down fix at 4,000 ft and the final approach, means an FAF.

- The crew used the ATIS Y information, and noted the unavailability of the glide;
- The crew was prepared for an approach «ILS y or LOC y RWY 36 R» using the Jeppesen 11-6 procedure plate below, with an MDA of 1,250 ft defined for the procedure without glide;
- Second in the arrival sequence, they were instructed to intercept the localizer for runway 36R and was instructed to «clear to app RWY 36 R LOC»;
- The crew was aware of the weather conditions;
- During the descent, they heard the controller order the preceding aircraft to go around.

It is difficult to understand the logic used by the crew to control the descent. While a short stepdown was observed at the minimum altitude of the first segment of the final approach, the trajectory passed under those of the second and third segments, to the point where there were no more obstacle clearance margins. The aircraft was then in the cloud layer and the crew no longer had any effective protection against obstacles, apart from a possible EGPWS warning. The flight parameters show that during the final approach, the wind was light and did not significantly affect the flight path of the aircraft. The monitoring of the approach path using the published distance / altitude correlation table, a technique mentioned in the airline company's procedures in addition to the use of the green arc, was clearly not applied. The event mentioned in 1.18.3 shows, however, that it is an effective barrier against the misidentification of the FAF.

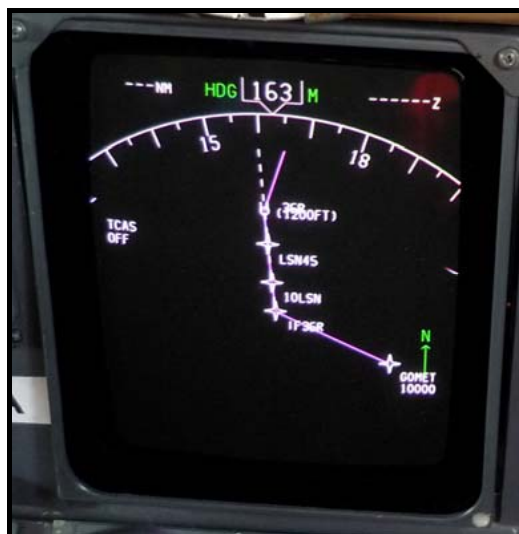
Figure 9 : Presentation of the approach on the EHSI

In conclusion, the approach is built with the final approach fix at 4,000 ft and 10 nm.
